COATING WORLD®

SPECIAL REPORT ON NONSTICK COATINGS AND HOUSEWARES FOR RETAILERS

Protecting Your Private Label's Bottom Line: How Free Product Testing From Whitford Works

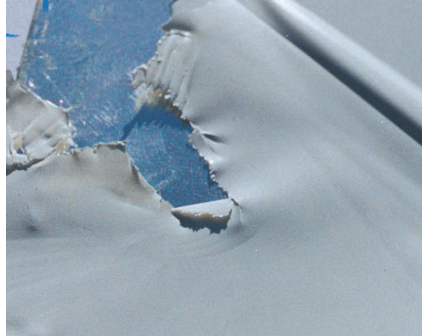
A severe case of coating failure due to improper cure time and temperature.

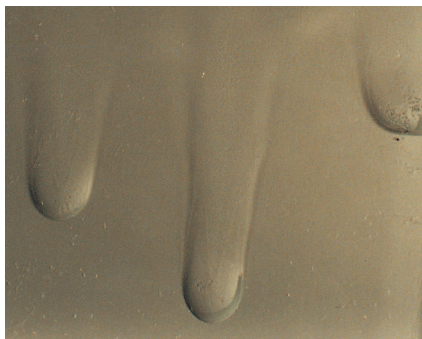
Sagging, caused by low viscosity or the coating is applied too thickly.

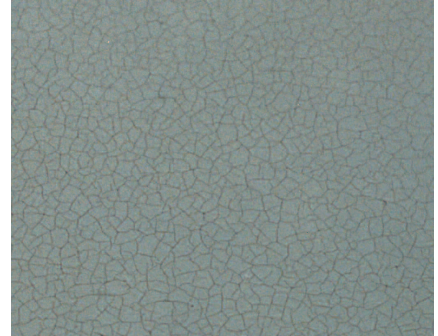
"Mud-cracking" caused by the application of too much coating.

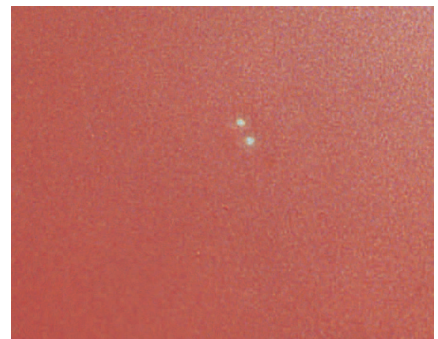
"Fish eyes", small holes caused by contaminants (such as fingerprints) on the surface.
