Solving Common Coating Problems

Using this chart

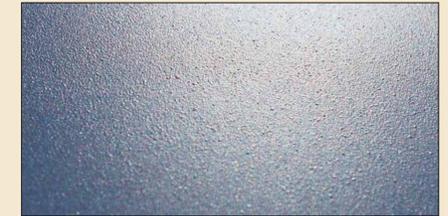
Dry spray

Appearance

A rough, mottled surface, similar to orange peel.

Probable cause

The coating is losing too much solvent as it is propelled toward the surface by the spray gun.

Suggested solutions

1. Move the spray gun closer to the surface; reduce the velocity of the spray; or increase the ratio of coating to air in the spray.
2. Change to a solvent that dries more slowly.

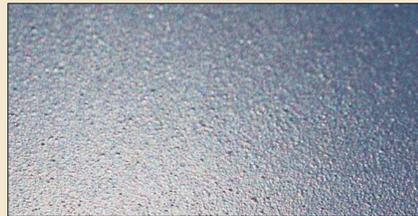
Eruptions in die-cast parts

Appearance

Occasional, random eruptions and/or small pockmarks.

Probable cause

Microcavities containing air in the metal. The air expands during curing, erupting (outgassing) and leaving either a small eruption or a crater.

Suggested solutions

1. Force eruptions prior to coating by preheating the parts to a temperature above the cure temperature. If no blisters appear, let parts cool, then coat and cure. If blisters still appear, the die-caster must make adjustments.
2. Select coating with lower cure temperature.

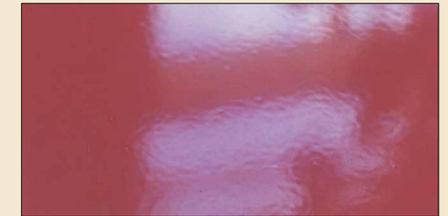
Orange peel

Appearance

Textured coating surface resembling skin of an orange.

Probable causes

1. High viscosity of the coating material.
2. High temperatures causing rapid solvent loss.

Suggested solutions

1. Decrease the viscosity and lower air pressure.
2. Reduce the temperature of the part.

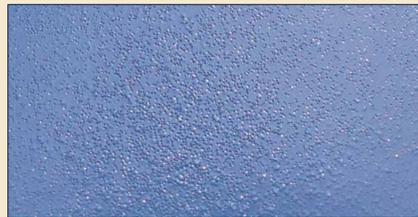
Overspray cratering

Appearance

Small particles of coating that reach a surface not intentionally sprayed (such as overspray from an interior non-stick reaching the exterior of a pan).

Probable cause

Too much overspray in application process.

Suggested solutions

1. Move the spray gun closer to the surface; reduce the velocity of the spray; or increase the ratio of coating to air in the spray.
2. Mask part to avoid overspray reaching other surfaces.
3. Increase air exhaust around parts to remove spray.

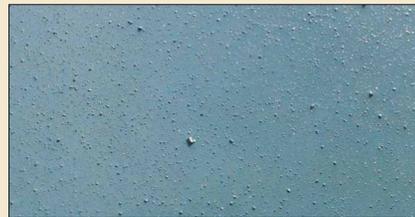
Particulate contamination

Appearance

Hard bits (particles) on surface of coated parts.

Probable causes

1. Dried coating inside container falling back into coating.
2. Airborne particles either in spray area or oven.

Suggested solution

1. Filter coating before using.
2. Keep spray area clean and free of dust.
3. Vacuum particulate matter from oven.
