# COATING WORLD<sup>®</sup>

## Keeping Nonstick Coatings Honest: Whitford's Testing Equipment And Methodology

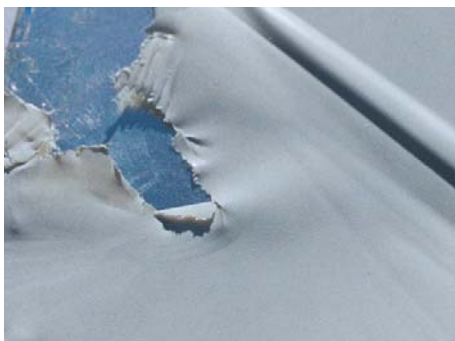
*A severe case of coating failure due to improper cure time and temperature.*

- **Improper cure:** A coating that is not cured ("baked") for enough time at the right temperature (or is cured for too much time) will not perform up to expectations.

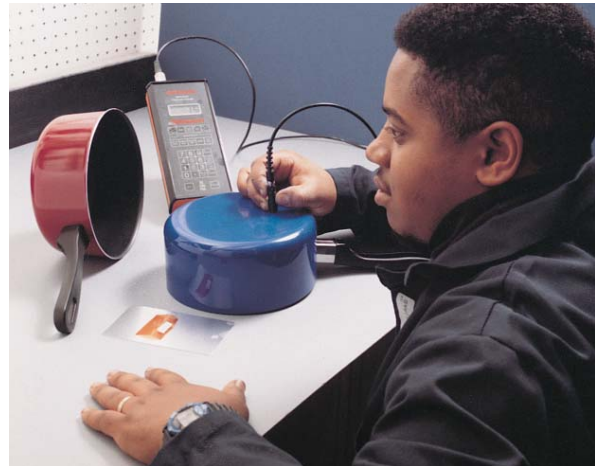
*Whitford's Test Method 114A (dry-film-thickness test) is fast and reliable, but does require having the right electronic equipment.*

In this procedure, Whitford measures the dry-film thickness of a coating using a magnetic induction or eddy-current electronic gauge.

The instrument is calibrated to zero over the bare substrate of the item being tested (a small portion of the nonstick is removed to permit calibration on the same pan on which the thickness of the nonstick is to be measured), or the uncoated bottom is used.

Three to six measurements of coating thickness over an area of five inches square are taken, then averaged. The result is compared to the dry-film thickness specified in the application instructions (every Whitford coating is delivered to applicators with detailed specifications on how to apply the coating correctly).
